Top Performance for Perfect Engine Operation

Recommended Installation of Water Pumps

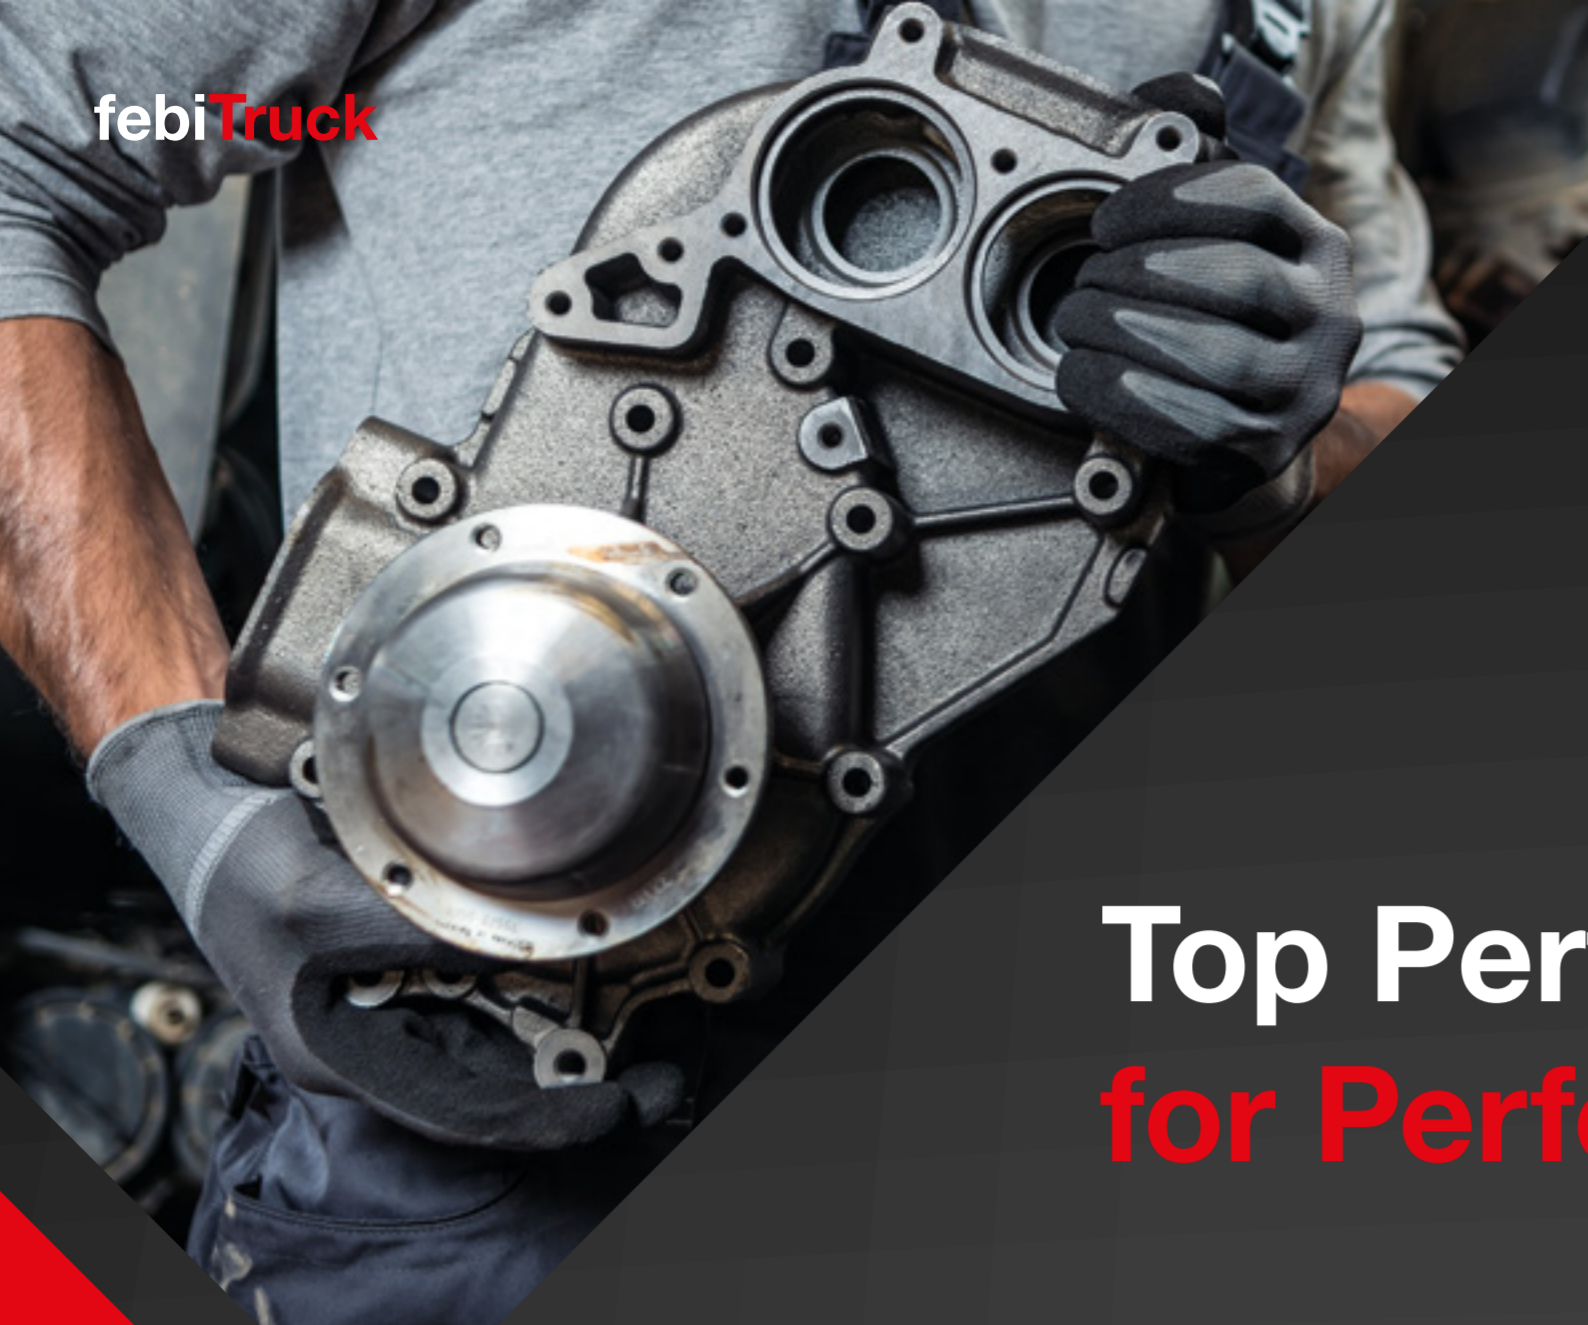
Damage symptom	Damage picture	Possible causes	Solution
Traces of condensation at leakage boring		<ul style="list-style-type: none"> Slight leaking of coolant as the gasket settles 	<ul style="list-style-type: none"> Observe for 1 - 3 operating hours
Coolant leaking from leakage boring		<ul style="list-style-type: none"> Corrosion in cooling system Operating with clean water 	<ul style="list-style-type: none"> Clean the cooling system
Broken housing		<ul style="list-style-type: none"> Incorrect fitting Damaged in transport 	<ul style="list-style-type: none"> Replace water pump
Excess sealing compound		<ul style="list-style-type: none"> Incorrect fitting 	<ul style="list-style-type: none"> Re-seal
Debris contamination		<ul style="list-style-type: none"> Incorrect cleaning of the cooling/lubrication system 	<ul style="list-style-type: none"> Flush cooling/lubrication system again
Uneven tooth-profile		<ul style="list-style-type: none"> Timing belt over-tensioned 	<ul style="list-style-type: none"> Change auxiliary belt and set correctly

Water leaking from hose connector/housing gasket		<ul style="list-style-type: none"> Sealing compound incorrectly applied Gasket has been fitted incorrectly 	<ul style="list-style-type: none"> Use sealing compound according to manufacturers' instructions Use gasket according to manufacturers' instructions
Pitting corrosion on impeller		<ul style="list-style-type: none"> High chloride concentration in water/coolant 	<ul style="list-style-type: none"> Flush cooling system Use recommended coolant
Corrosion in the entire cooling system		<ul style="list-style-type: none"> Faulty cylinder head gasket Use of coolant not compliant with manufacturers' specifications 	<ul style="list-style-type: none"> Replace cylinder head gasket Clean cooling system
Faulty gasket		<ul style="list-style-type: none"> Contamination of cooling system Use of unsuitable fluids / wrong mixing proportions applied Too much pressure in cooling system Faulty cylinder head gasket Wear 	<ul style="list-style-type: none"> Replace water pump

Faulty water pump bearing		<ul style="list-style-type: none"> Strong vibrations caused by faulty fan coupling Incorrect belt tension Sealing compound incorrectly applied Wear 	<ul style="list-style-type: none"> Replace water pump
Cavitation in the water pump housing		<ul style="list-style-type: none"> Wrong coolant Wrong water/coolant mixture Pressure in the cooling system is too high 	<ul style="list-style-type: none"> Check and flush the cooling system thoroughly Change the water pump Use the recommended coolant in the right mixing ratio
